Little Quilcene-Leland Watershed
Rapid Habitat Assessment and Prioritized Restoration Framework

Technical Report

prepared by Wild Fish Conservancy

September, 2008

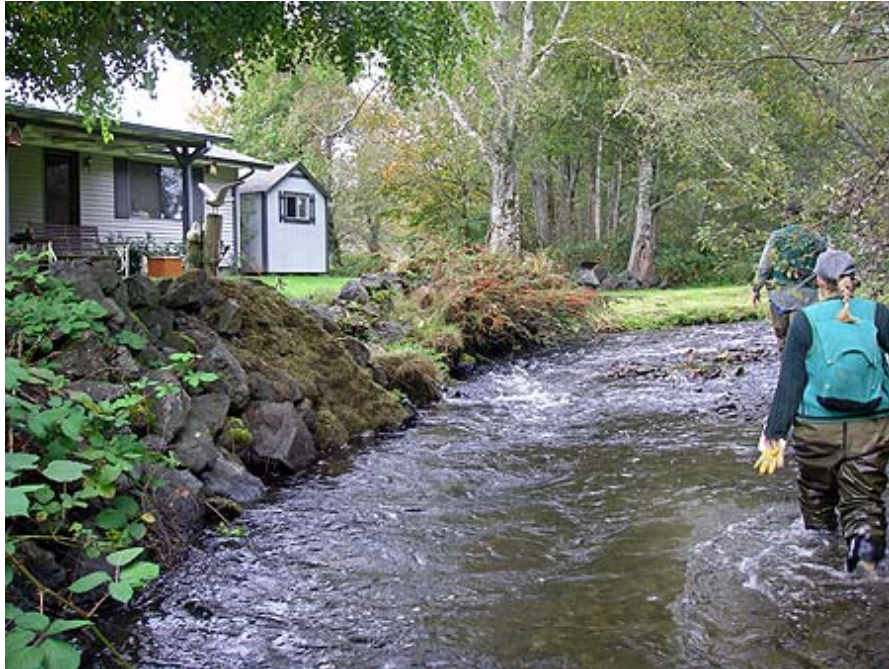
Photo 3 – Wild Fish Conservancy field crews reconnoiter a sub-reach (1A) along the lower Little Quilcene River that has been subject to over-development – note bank armoring and landscaped lawn (w/ non-native vegetation) extending to river's edge.

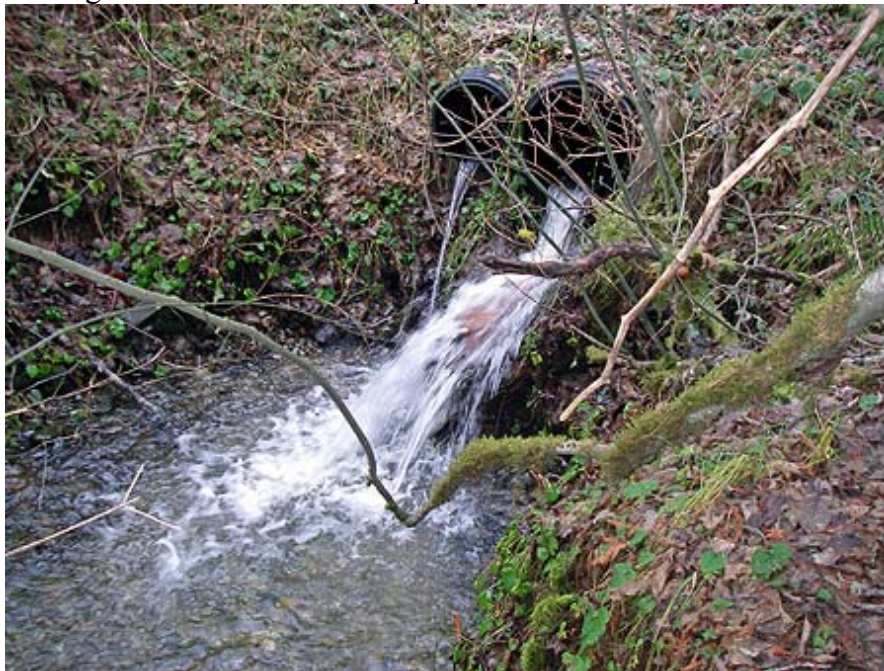
Photo 8 – Barrier culvert outlet at a private road crossing of a fish-bearing stream.

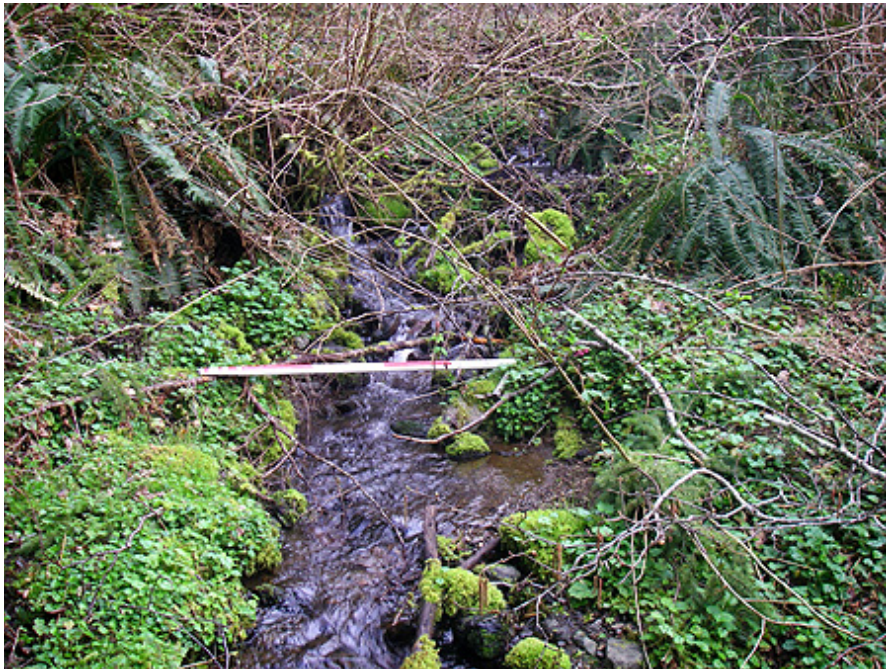
Photo 9 – Headwater tributary stream typical of those targeted by WFC for water type investigations in the Little Quilcene watershed. A noticeable gradient change is the demarcation between fish-bearing (Type 3) and non fish-bearing, perennial (Np / Type 4) habitat – clearly visible where the stadia rod crosses the stream channel.

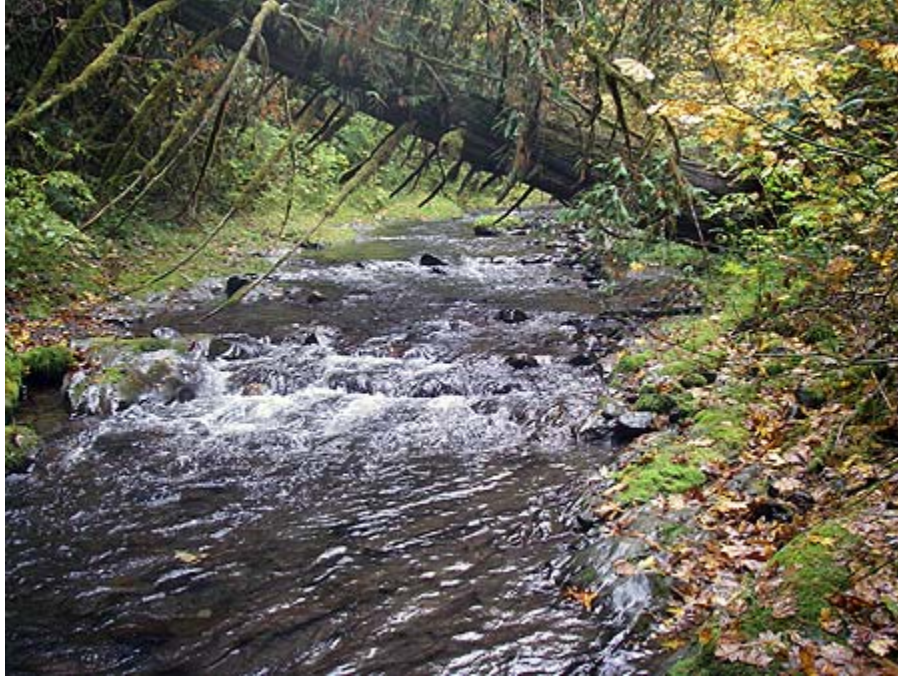
Photo 10 – Riparian corridors on upstream reaches of the Little Quilcene River are generally intact (note large cedar tree on the verge of falling into stream, contributing LWD), but these reaches are outside the primary productive salmon spawning grounds (photo shows that substrates are mostly bedrock and angular cobble).

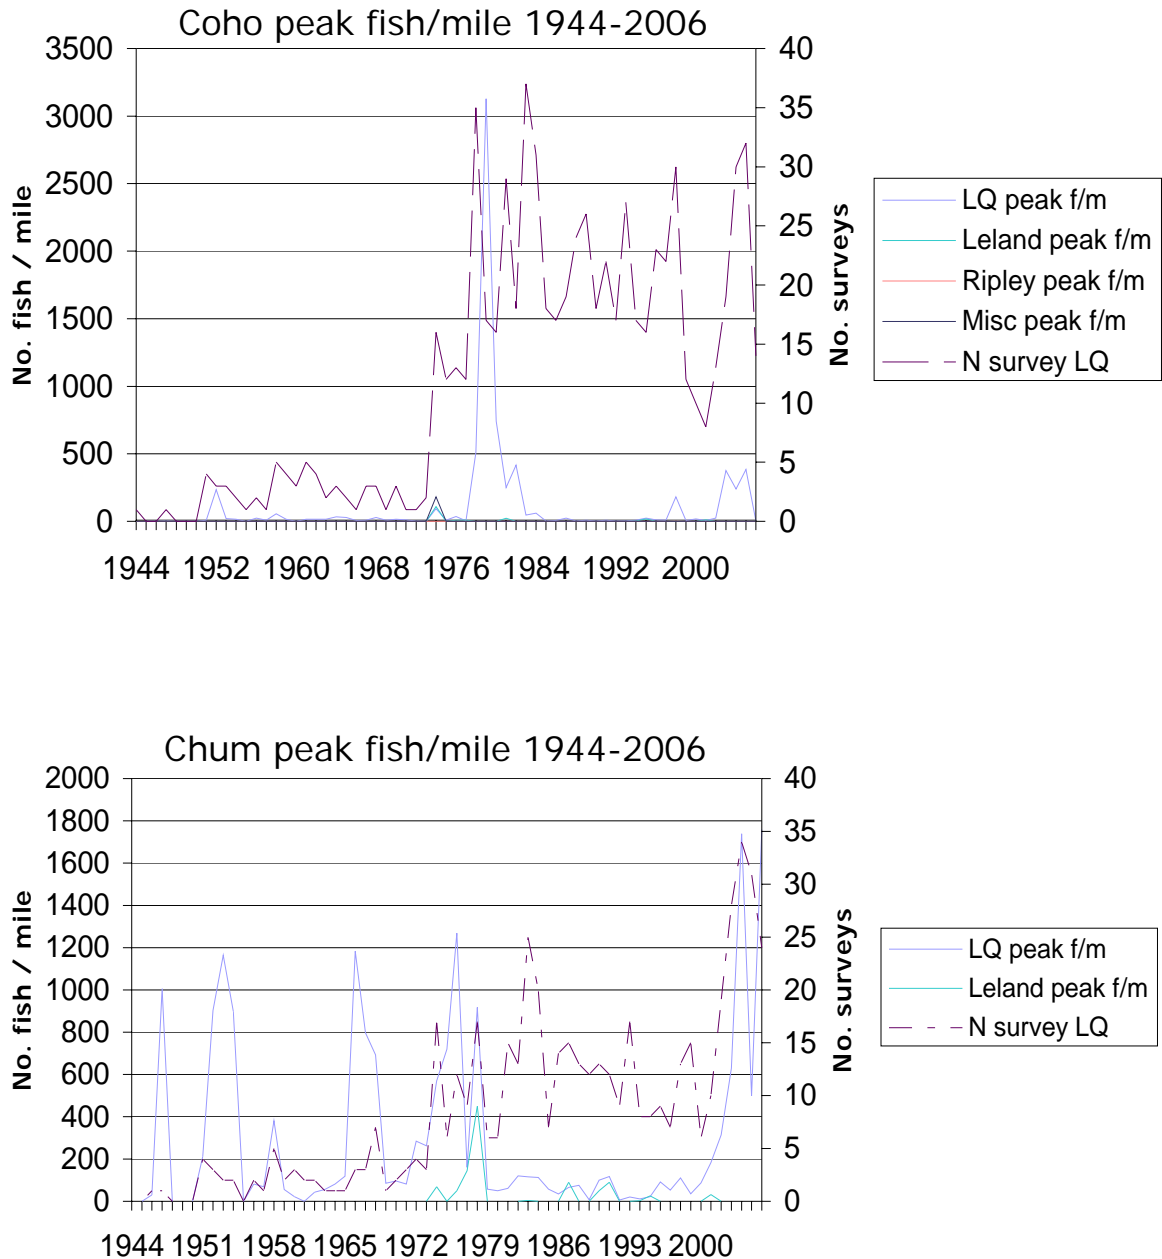
Figure 2 – Density (fish/mile) of coho and chum salmon in the Little Quilcene River, Leland and Ripley Creeks (Washington Dept. of Fish and Wildlife data, 1944-2006).

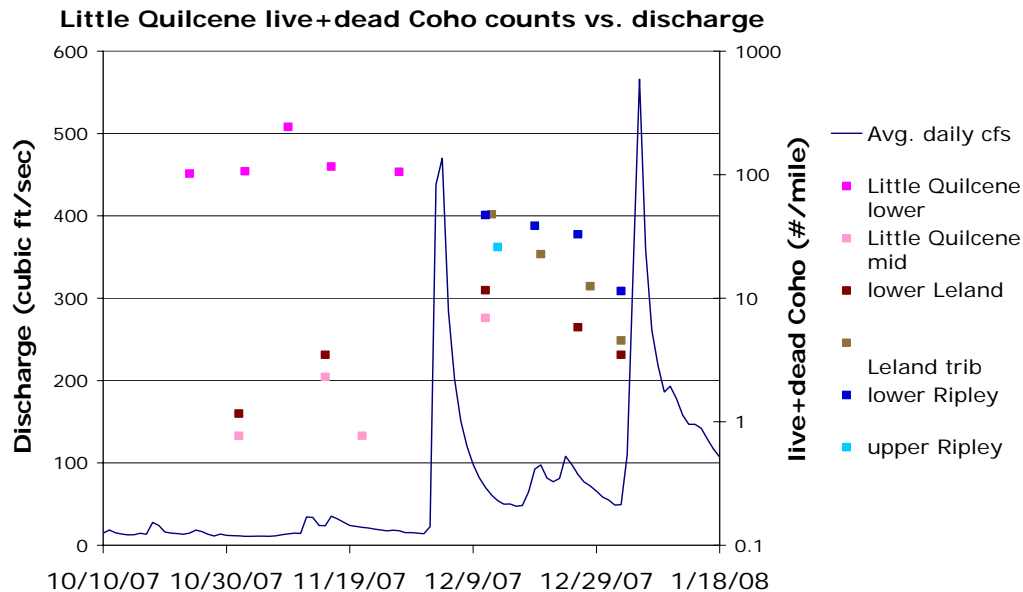
Figure 3: Density of live + dead coho salmon (# per mile) relative to mainstem stream gauge flow data in the Little Quilcene River and tributary index reaches for 2007-2008.

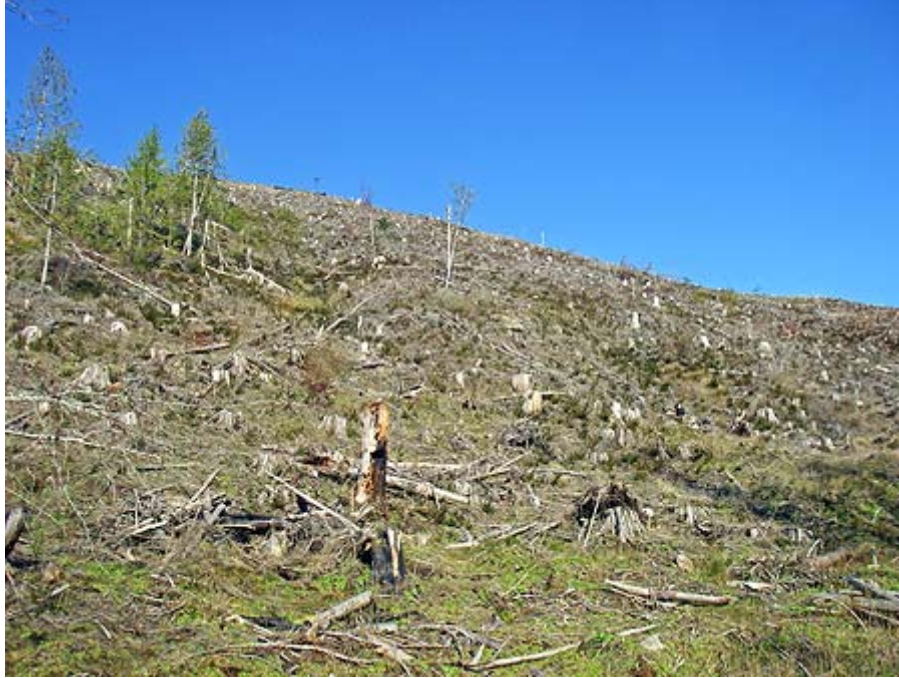
Photo 11 – The few remaining trees in the upper left of the photo supposedly “buffer” a spring-fed seasonal tributary to the headwaters of Ripley Creek.

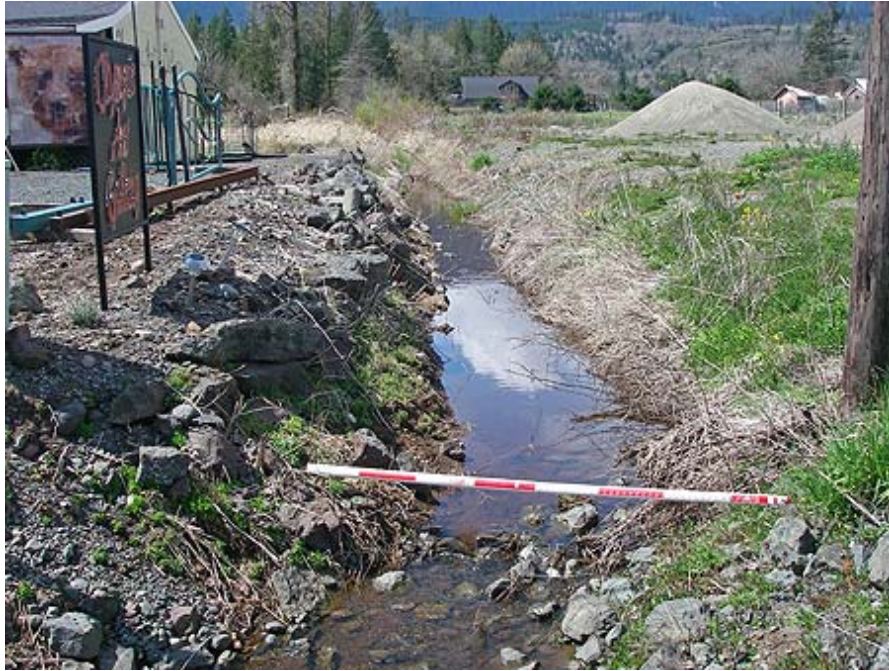
WFC water type surveys also documented juvenile coho rearing in an agricultural ditch referred to locally as “Cemetery Drain” (see Part II, pg. 26 and Map 2, Appendix 1). This previously un-mapped ditch flows along a narrow riparian corridor of medium-sized alder trees upstream from a separate tidewater confluence at the head of Quilcene Bay (between the mouths of the Little Quilcene and Big Quilcene Rivers). Cemetery Drain crosses Center Road and Highway 101 via large-diameter culverts, and continues through downtown Quilcene as an open ditch while crossing local roads through several smaller culverts. Invasive Himalayan blackberries obscure the channel below the highway crossing, and the channel flows for long distances in an open ditch through agriculture fields and pastureland surrounding a (now greatly-reduced) former valley-bottom wetland complex. The channel originates at several small but perennial spring-fed seeps to the west and northwest of Cemetery Road. Compromised water quality due to elevated temperatures, agricultural run-off, and greater risk of predation from lack of cover indicate that Cemetery Drain is also a likely sink for Quilcene Bay coho populations.

Photo 12 – Salmon habitat in downtown Quilcene; upstream view of Cemetery Drain.

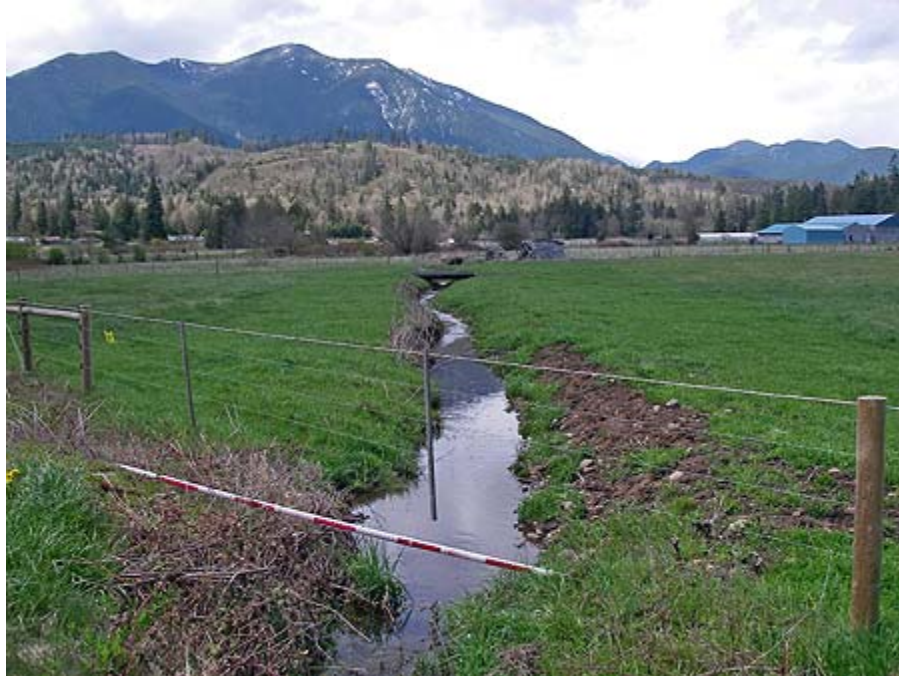
Photo 13 – Highly degraded habitat: a former Type 3 fish-bearing tributary stream that was converted to an agricultural drainage ditch flowing through pastureland (Cemetery Drain).

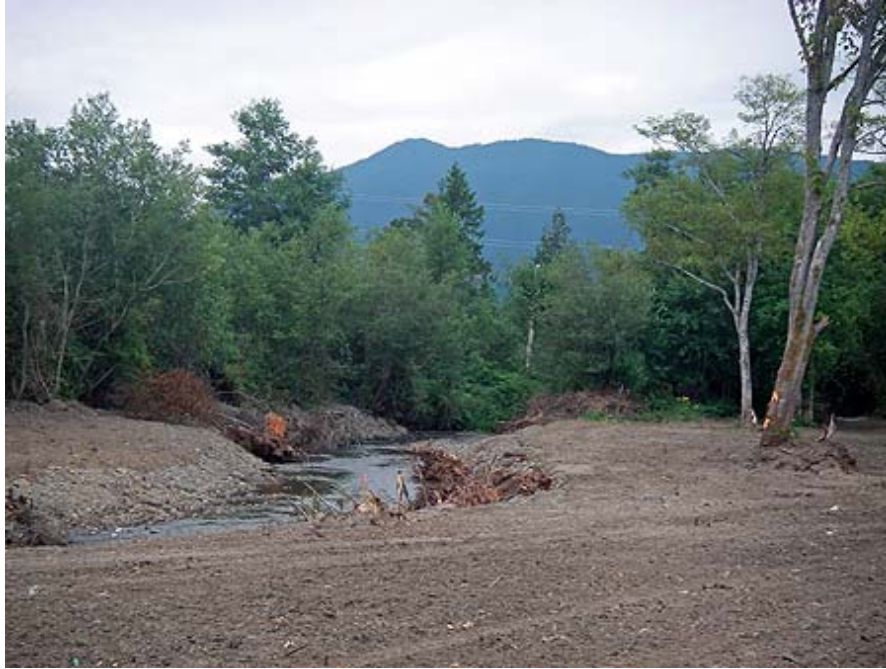
Photo 15 – Ongoing (August 2008) restoration of lower Little Quilcene River by HCSEG includes levee removal, construction of a meandering channel, supplementation with large woody debris, and eventual planting with native riparian vegetation.

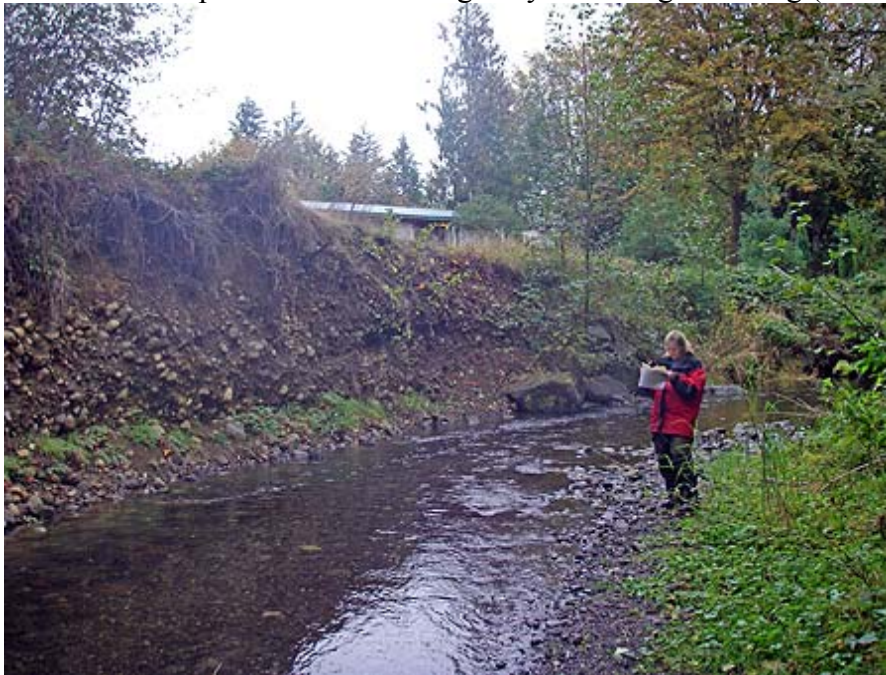
Photo 16 – Erosion of Little Quilcene River left channel bank (Reach 3, sub-reach 3a) at the site of a former bank stabilization project (note boulder riprap in background).

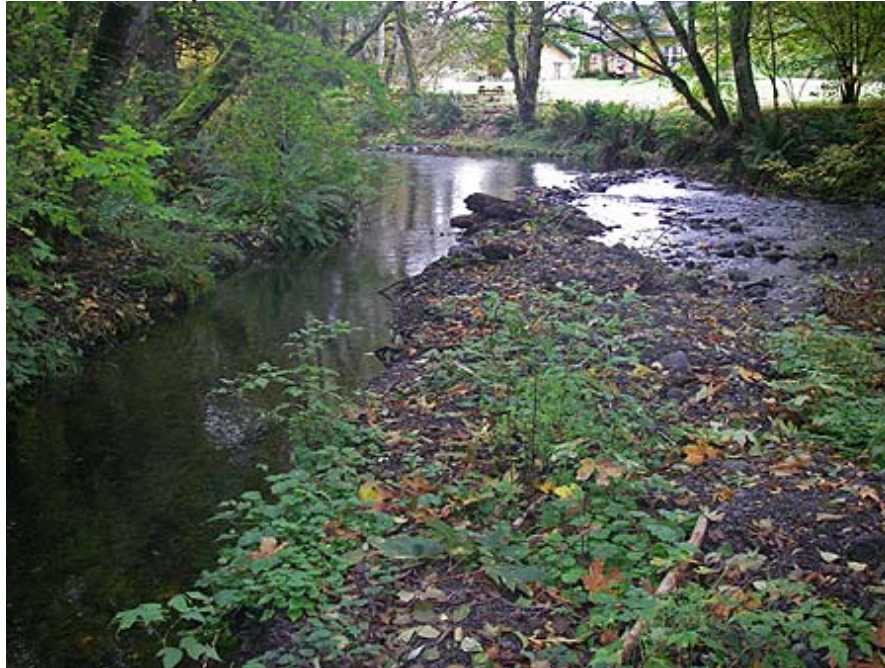
Photo 17 – Early autumn low-flow upstream view at the “Wildwood Diversion Canal” entrance showing de-watering that occurs in the mainstem Little Quilcene River (right).

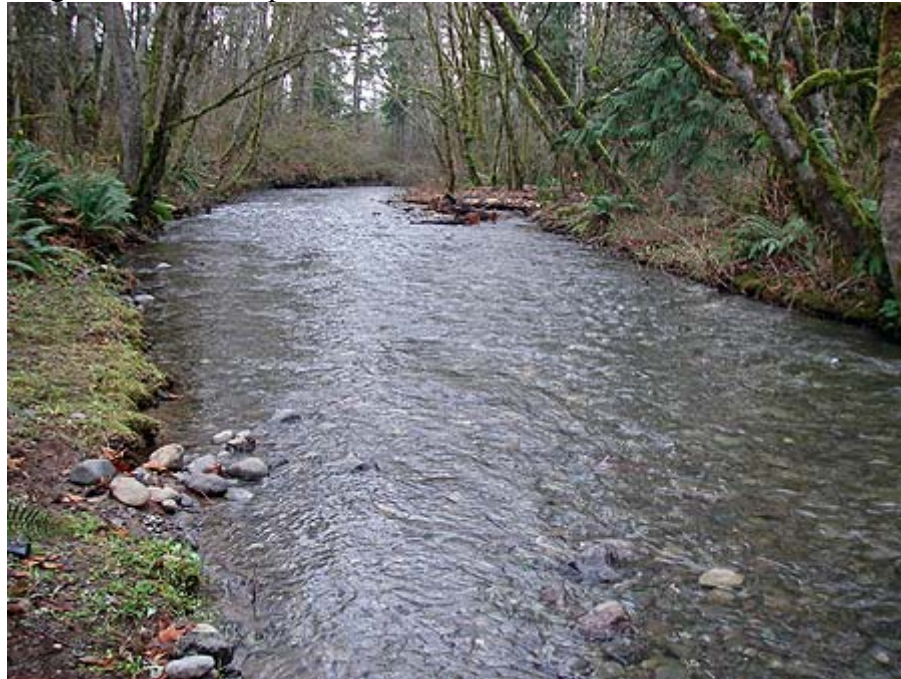
Photo 18 – View of the cobble diversion dam (remains are visible on left-bank) after seasonal high flows have flattened the dam and re-distributed channel substrates. Several logs are visible at the right-bank entrance to the “Wildwood Diversion Canal” downstream.

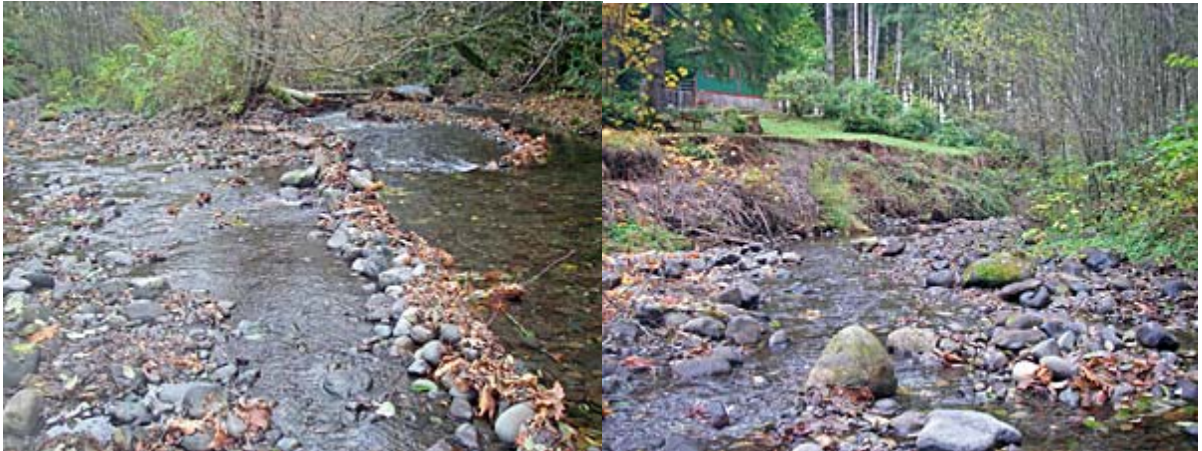
Photos 19-20 – Downstream view of another cobble diversion dam (left) near the upper extent of sub-reach 3b. “Push-up” dam diverts flow from an eroding left-bank bluff (right), but de-waters the downstream split channel.

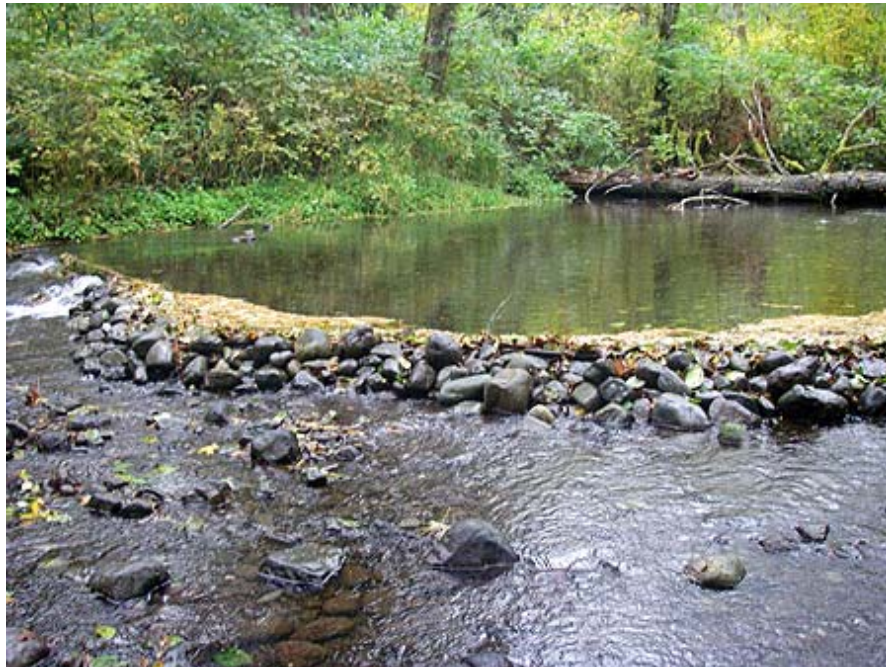
Photo 21 – Upstream view of a third cobble “push-up” dam; Little Quilcene, Reach 6.

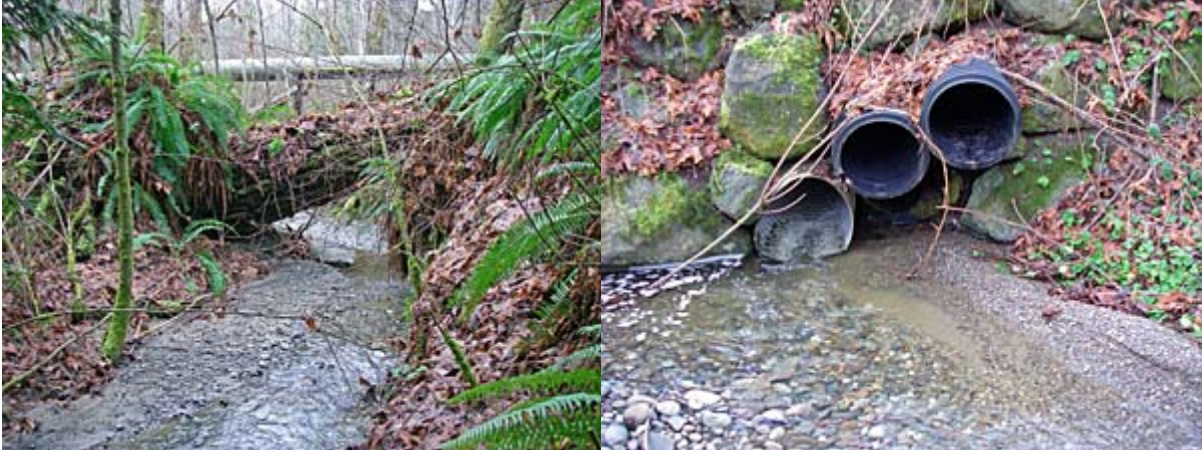
Photos 22-23 – A view of “Wildwood Creek” ~350 ft. upstream from the Little Quilcene River confluence (left), and ~50 ft. below a barrier culvert crossing of Big Leaf Lane (right). The “Wildwood Diversion Canal” crosses the Wildwood Creek ravine via a suspended aluminum pipe, and the culvert barrier disconnects several-thousand feet of potential mainstem and tributary anadromous habitat upstream from Big Leaf Lane.

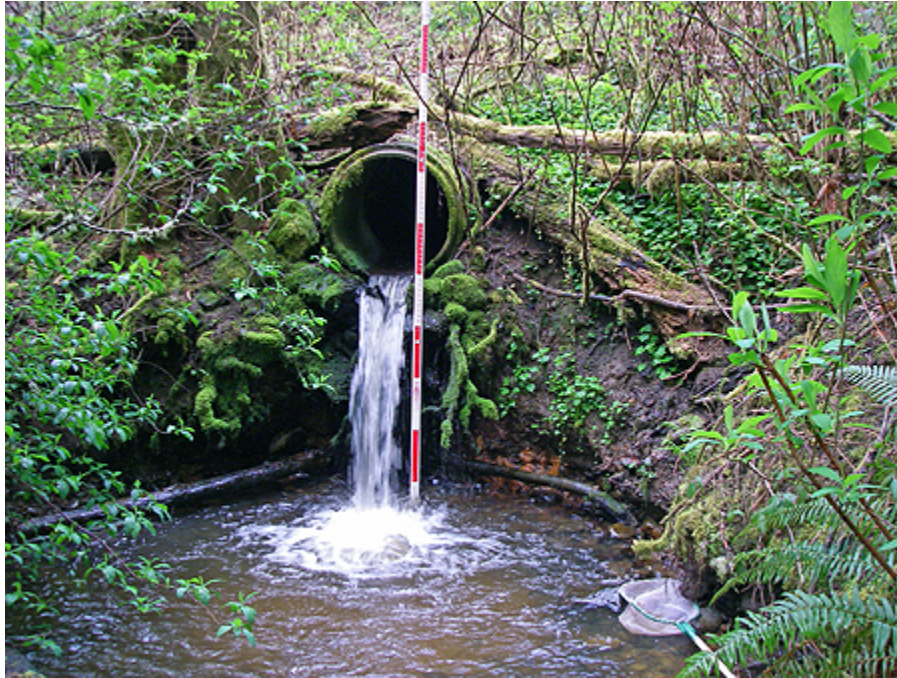
Photo 24 – Barrier culvert crossing of Leland Valley Road West on the 17.0078 tributary.

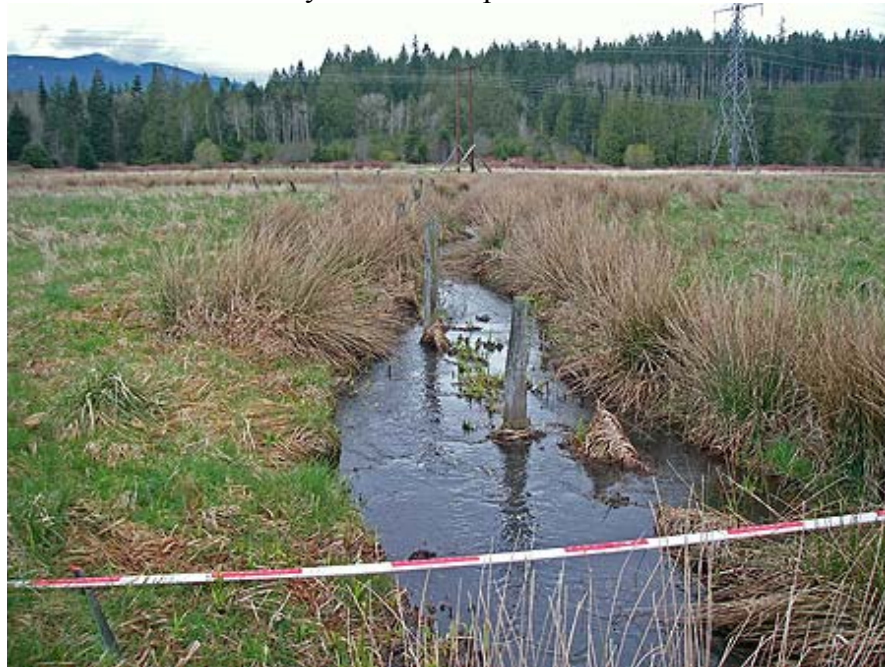
Photo 27 – Downstream view along the degraded south fork headwater tributary of WRIA 17.0080 (tributary *H-a*). Note extensive incursion of non native grass beginning to green-up. WRIA 17.0080 continues downstream in a forested valley that begins at the distant tree-line.

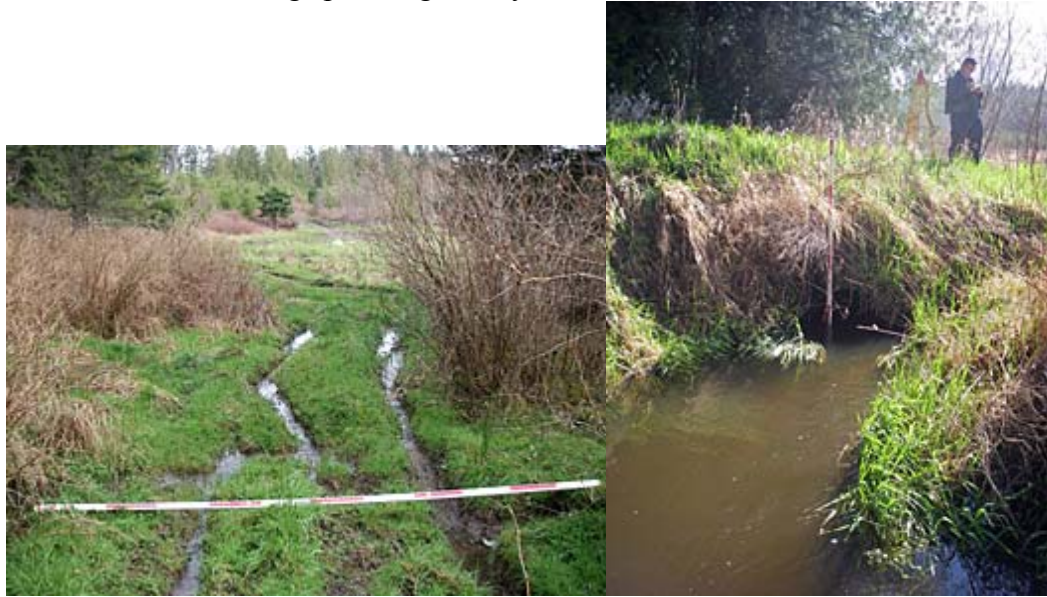
Photos 28-29 – Ns (Type 5) seasonal tributary channel eroding an old road-bed in a headwater area that receives heavy use by OHVs (left), and in-stream sedimentation visible at a (non-barrier) culvert outlet just below the confluence of the 17.0080 Leland tributary and its south fork (17.0080 *H-a*).

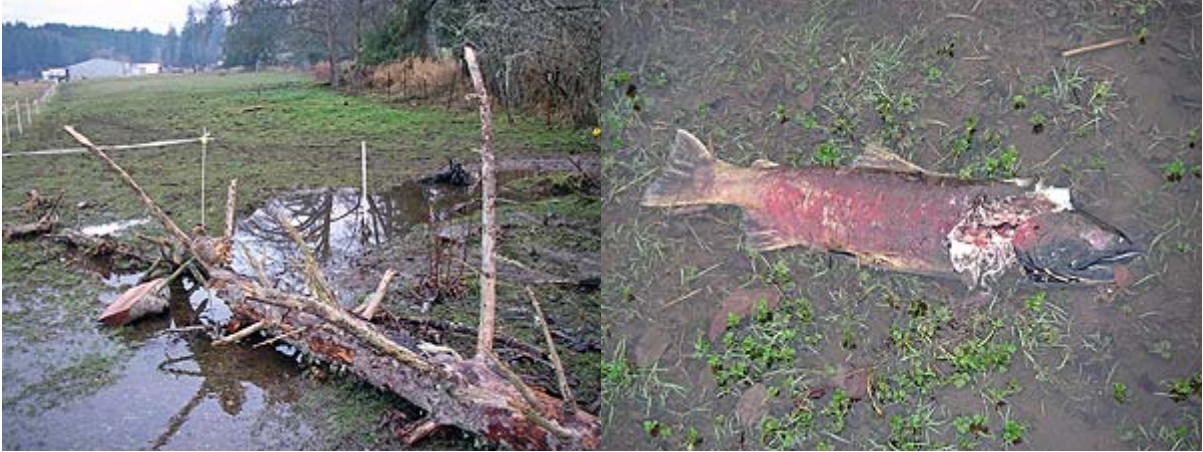
Photos 30-31 – Inadequate livestock fencing setbacks (left) on the 17.0080 tributary near the confluence with Leland Creek; a common occurrence on streams flowing through pastureland throughout Leland Valley. An adult male coho stranded in a flooded field (right), and then killed by otters before it had an opportunity to contribute to the genetic pool of the next generation of wild salmon.

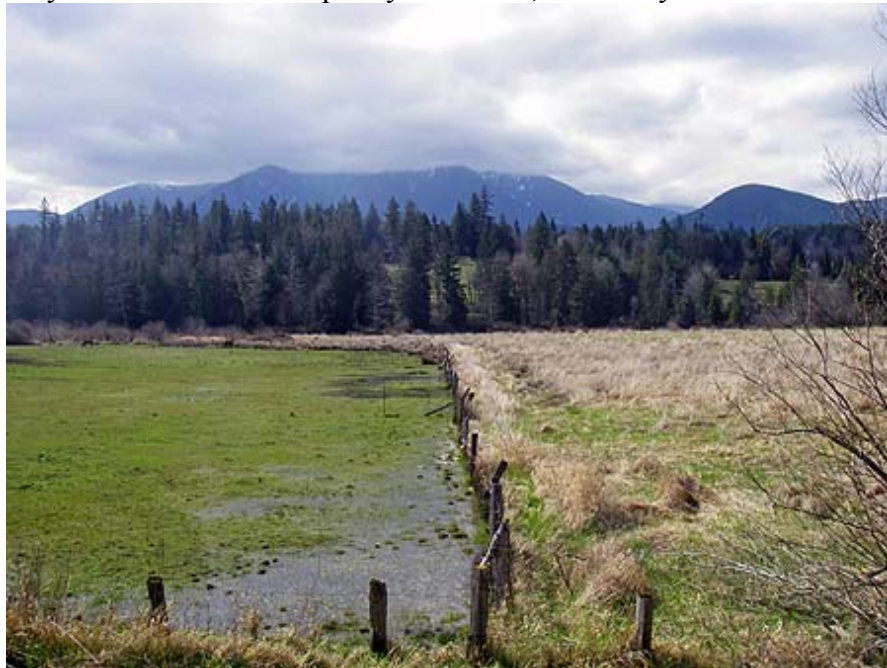
Photo 32 – Fence-line separates reed canary grass-dominated wetland just below the outlet of Lake Leland from fish-bearing (Type 3) tributary 17.0017I that vanishes in pastureland before reaching a confluence with Leland Creek (in the background against the forested ridge).

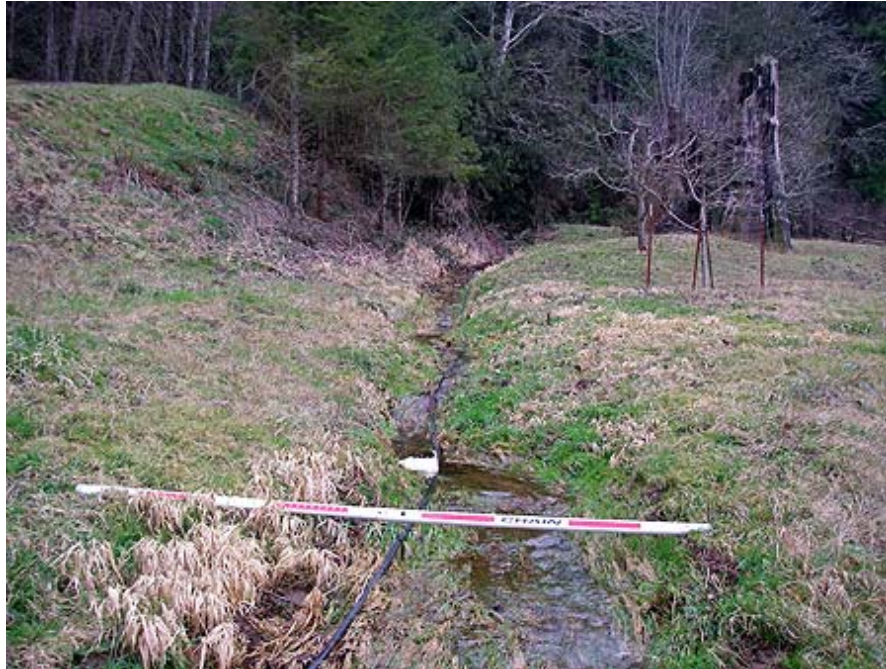
Photo 33 – Channel diversion that disconnects fish-bearing (Type 3) habitat from tributary 17.0017Q-d emerging from a side canyon upstream from the Upper Leland Valley wetland.

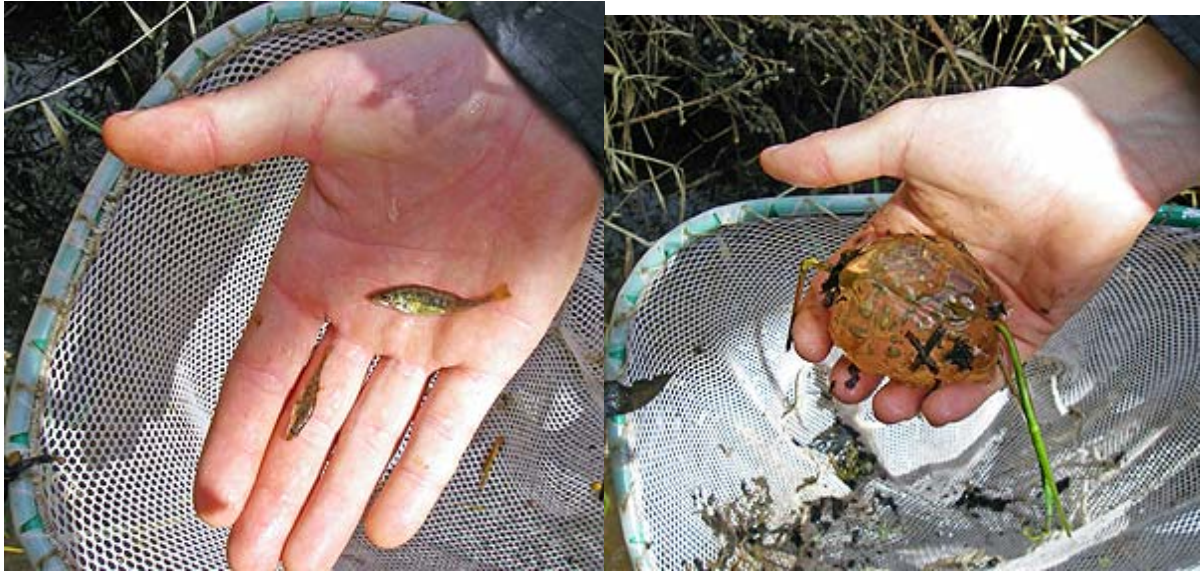
5. The Boulton Farm spans the upper reaches of both Andrews Creek (WRIA 17.0221) and the headwater tributaries to the Upper Leland Valley wetland complex (17.0017Q-e/f, Map 4). Native fish access to the fish-bearing (Type 3) tributaries traversing the property would benefit from the replacement of two barrier culverts located along a ditched portion of the western headwater tributary (PC #47, 48, Appendix 2). The landowner (Appendix 3, #10) may also be amenable to a complete restoration of the two channels that could eventually be utilized for spawning if native salmon and steelhead are encouraged to return to Lake Leland and upstream tributaries. Three-spine stickleback were discovered just below the outlet of the lower culvert. Stickleback are a native fish capable of withstanding degraded water quality and high stream temperatures, often surviving in stream conditions where trout and salmon would be jeopardized. Amphibians use the channels and adjacent wetlands for reproduction. Both streams are spring-fed Type 4 tributaries exiting areas of extensive upslope logging (observed riparian buffers adhered to state forest practice minimums), but are now confined within ditches through livestock pasture on the valley floor.

Photos 34-35 – Three-spine stickleback (*Gasterosteus aculeatus* - left) and frog egg masses (right) located at the ditched outlet of barrier culverts along the 17.0017Q-f tributary to the Upper Leland Valley wetland complex.

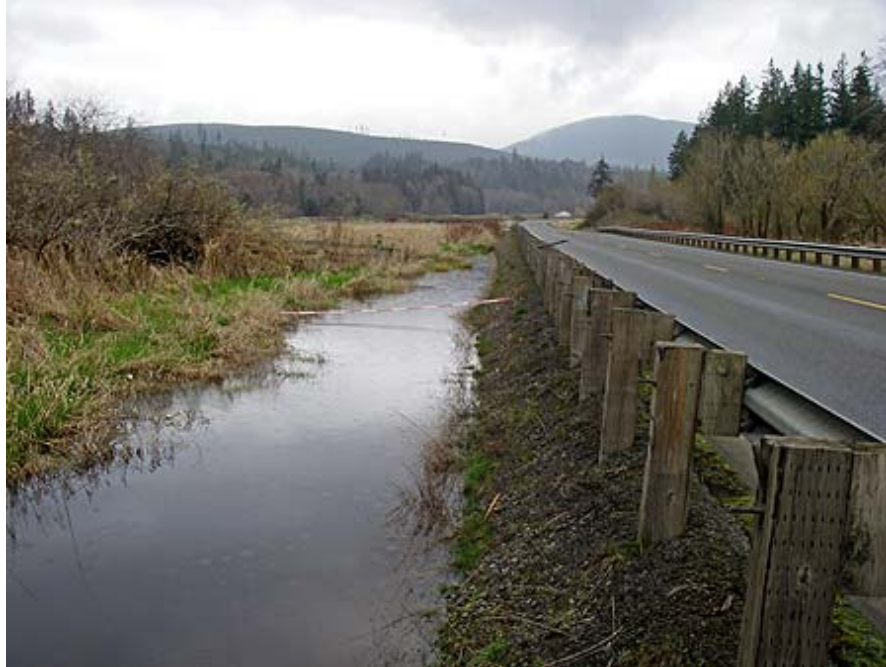
Photo 36 – Wetland habitat in Upper Leland Valley now relegated to a ditch along Highway 101. Fish-bearing (Type 3) habitat continues for several thousand feet further upstream along eastern (17.0017Q-d) and western (17.0017Q-e/f) headwater tributaries. All run-off into this ditch eventually enters Lake Leland approx. 2 miles downstream.

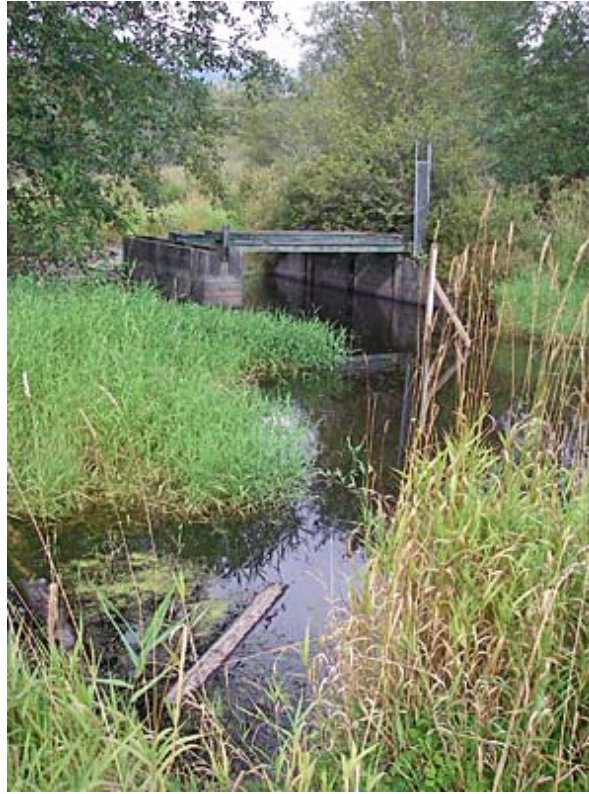
Photo 37 – Defunct fish weir and reed canary grass invading the channel at the Leland Creek outlet from Lake Leland.

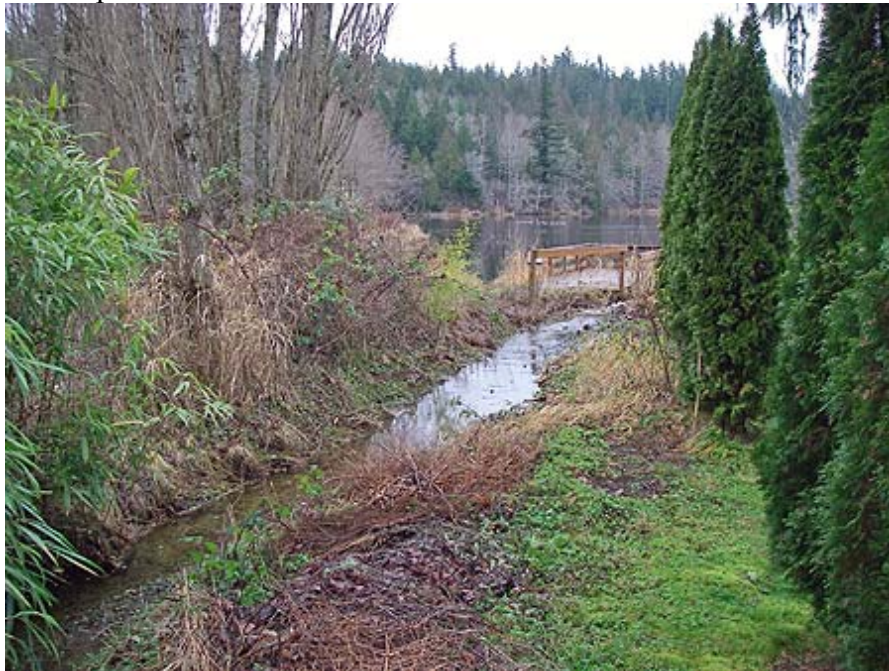
- e. Tributary 17.0017N enters Lake Leland near the end of Munn Road (Map 5). This tributary has several thousand feet of newly-mapped fish-bearing habitat above the lake confluence. Although the Munn Road culvert is not a fish passage barrier, the stream both above and below the culvert is heavily overgrown with invasive vegetation (esp. Himalayan blackberry and English

ivy), and the channel is armored and rip-rapped through several residential properties downstream toward the lake (incl. parcel #802261012). Native riparian cover has largely been removed along this reach, replaced by residential landscaping and non-native commercial plants along the banks. A wooden dock is located directly adjacent to the stream mouth where reed canary grass partially obscures the lake confluence. The landowners at the confluence (Appendix 3, #8) may be open to native riparian restoration, and should be included in community meetings discussing water quality concerns and the potential return of salmon to Lake Leland and watershed tributaries.

Photo 38 –confluence of the 17.0017N tributary on private property on the southwest shore of Lake Leland. Fish-bearing habitat extends upstream beyond Snow Creek Road.

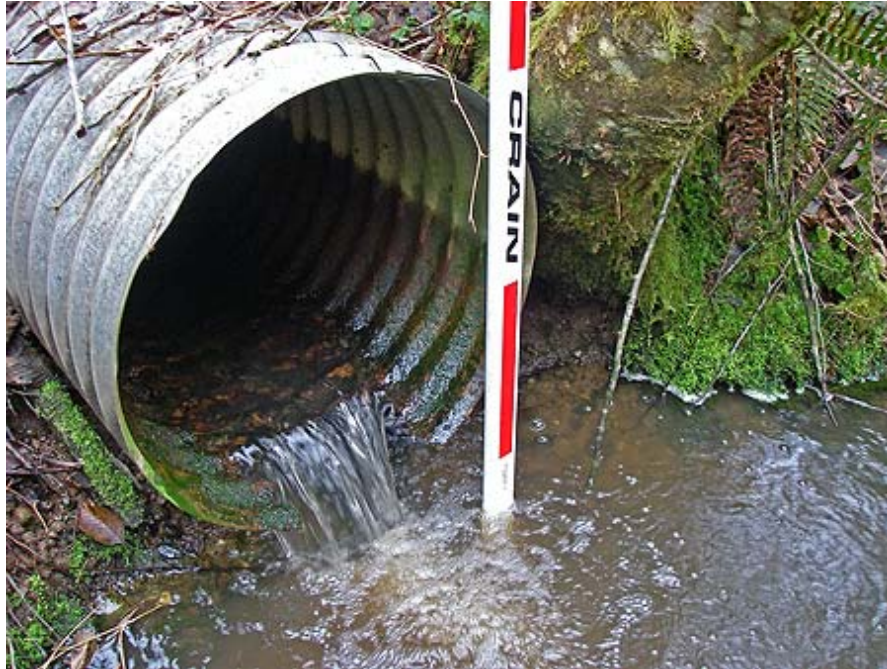
Photo 39 – Barrier culvert crossing of a decommissioned logging road along newly-mapped Type 3 habitat on a headwater reach of the 17.0017N tributary to Lake Leland.

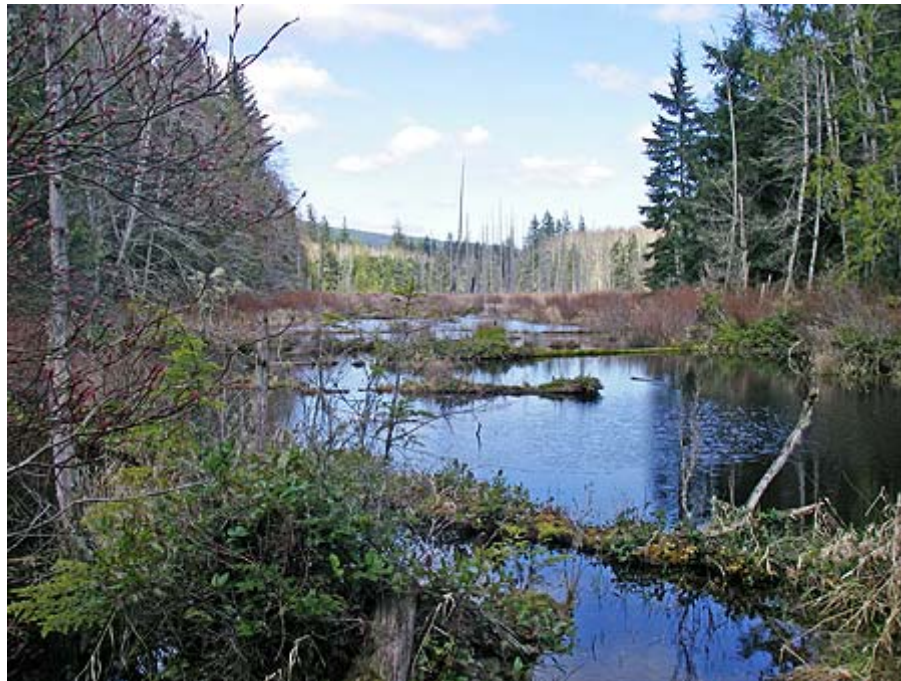
Photo 40 – Extensive beaver pond wetland located just upstream from a culvert crossing of Snow Creek Road (CC 95) at the headwaters of the 17.0017N Lake Leland tributary.

- f. A small man-made dam and impoundment along a headwater reach of the 17.0017N tributary (see Leland #6e above and Map 5) is a complete fish-passage barrier, causing the Type 3 stream to flow subsurface for a distance. This structure is located on private property (ORM) several hundred feet below the Snow Creek Road culvert crossing. A restoration project to reconnect newly-classified fish-bearing habitat with a headwater beaver pond to the north of Snow Creek Road could include removal of the small dam, and the replacement of two barrier culverts (PC #2 and CC #95, Appendix 2).

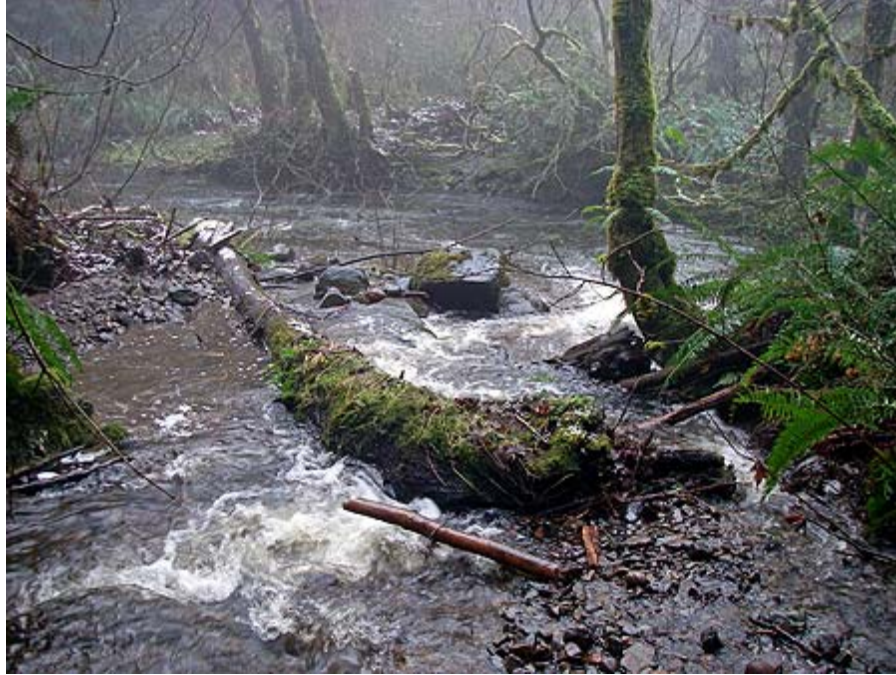
Photo 42 – High water view of channel-spanning log at the mouth of Ripley Creek; the log is a partial barrier to fish migration during late summer / early fall low flows.

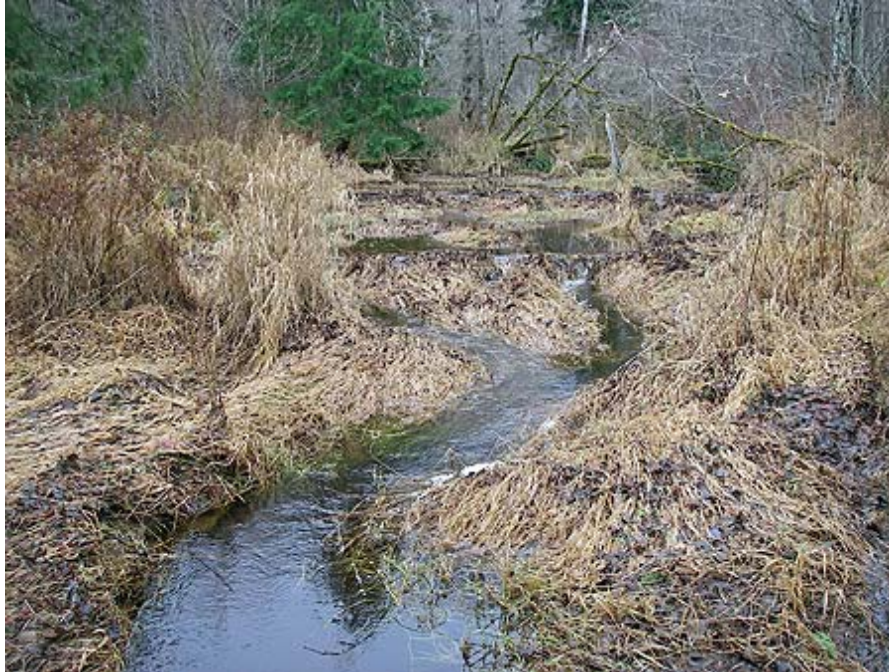
3. The riparian corridor along the “beaver pond reach” of lower Ripley Creek is completely dominated by invasive plant species, with the stream reduced to multiple narrow channels threading through dense swaths of reed canary grass.

Photo 43 – Downstream view of reed canary grass-dominated wetland habitat created by beaver activity near a local powerline crossing in sub-reach 1B of lower Ripley Creek.

Restoration of this reach (sub-reach 1B, Part III) by removing the non-native vegetation and planting of both conifer and deciduous trees and shrubs would contribute to the long-term enhancement of aquatic and riparian habitats, and improve short-term passage of coho salmon into upstream spawning grounds.

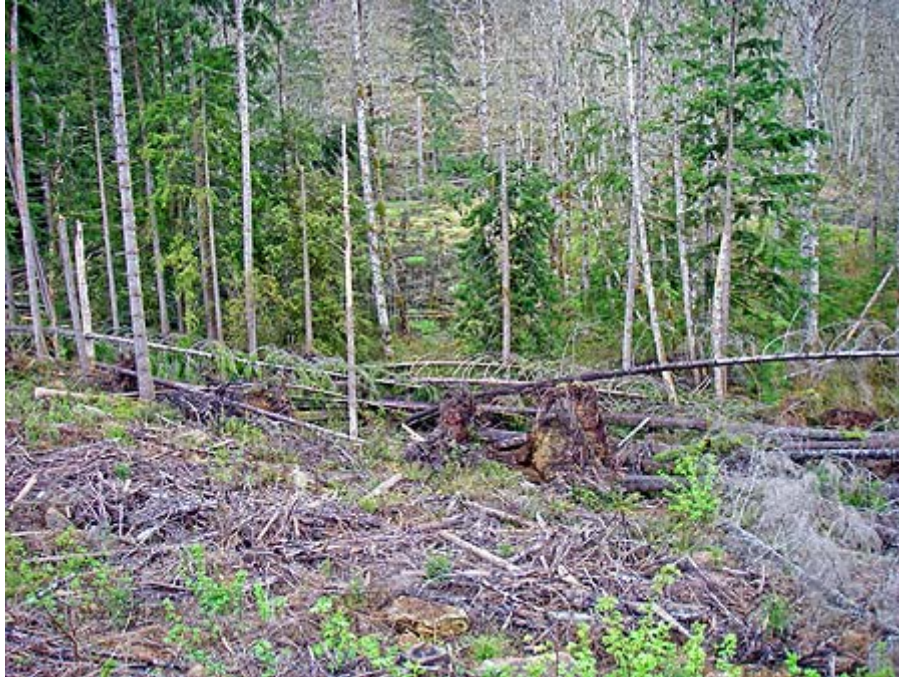
Photo 46 – Blowdown of conifer trees in the riparian buffer surrounding a beaver pond wetland (visible in background) in the recently clearcut headwater basin of Howe Creek.

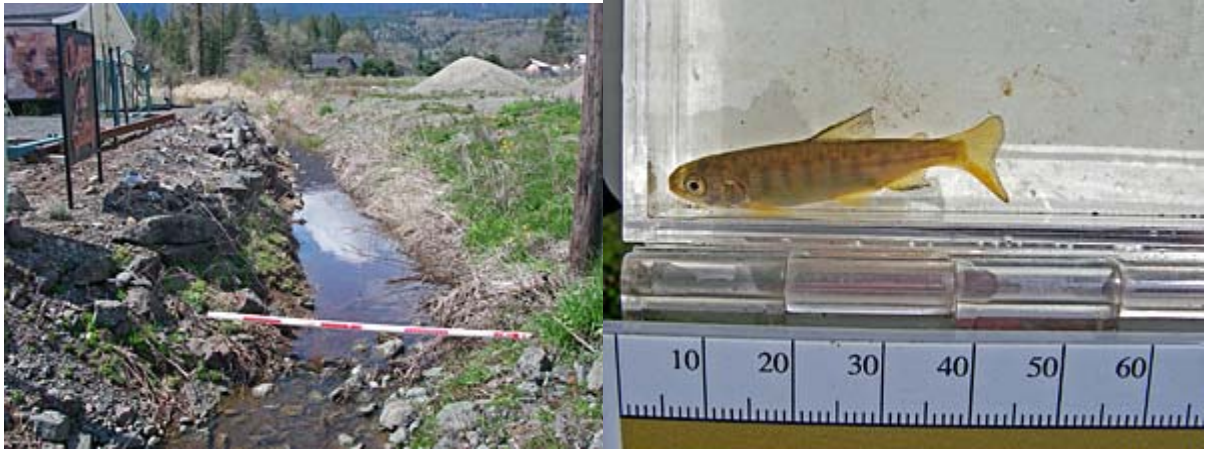
Photos 47-48 – Salmon habitat?! Cemetery Drain traversing the outskirts of Quilcene (left), and a single individual from a large school of juvenile coho discovered in Cemetery Drain in downtown Quilcene (right).
